AginCourt Resources's Response to the Garoga Flood: Fast, Fact-Based Action

Jakarta, December 2, 2025 – PT Agincourt Resources (PTAR) extends its deepest condolences and sympathy to the families of all victims affected by the recent flash flood and landslide disaster in Batang Toru Sub-district, South Tapanuli. Our thoughts and prayers are with the victims, their families, and all the communities impacted by this tragic event. We continue to mobilize all resources to ease the burden on the affected communities.

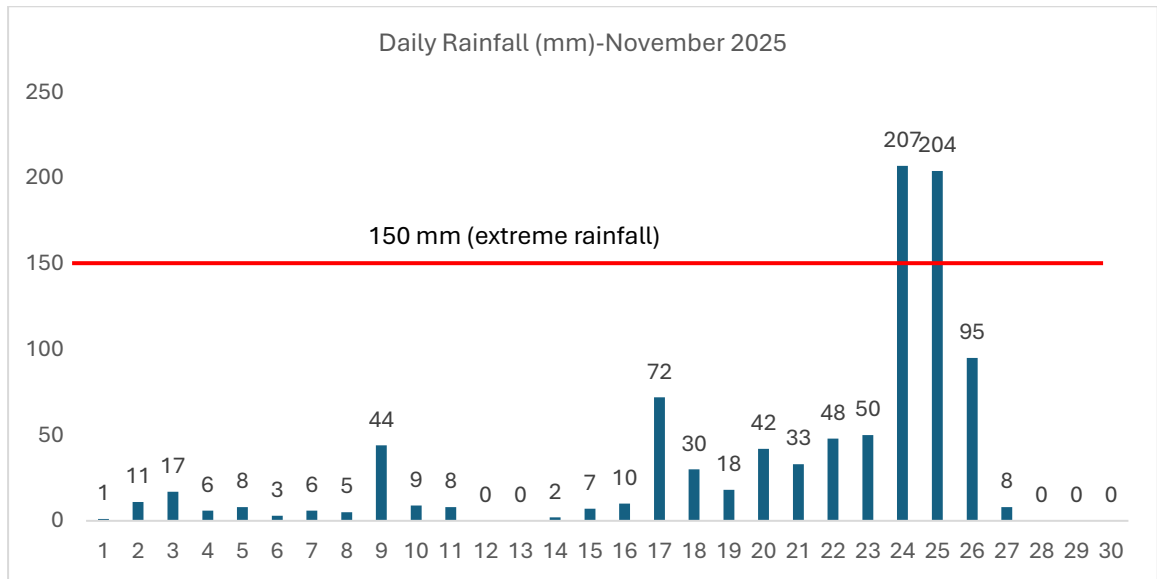
Figure 1. Rainfall Record in the Martabe Mine Area (Permata Camp)

- The disaster was immediately preceded by the influence of the Senyar Cyclone, which generated rainfall of extremely heavy intensity across the South Tapanuli region. Based on statistical analysis, this rainfall volume was so extraordinary (refer to Figure 1 for data comparison) that represents a maximum rainfall event that has not occurred for at least the last 50 years. This exceptional volume of precipitation fell uniformly across a vast area of Northern Sumatra, critically impacting the Batang Toru Forest area. The Batang Toru Forest serves as the upstream headwaters for the primary rivers flowing through the Batang Toru Sub-district, including the Garoga River (Aek), Aek Pahu, and the Batang Toru River itself.

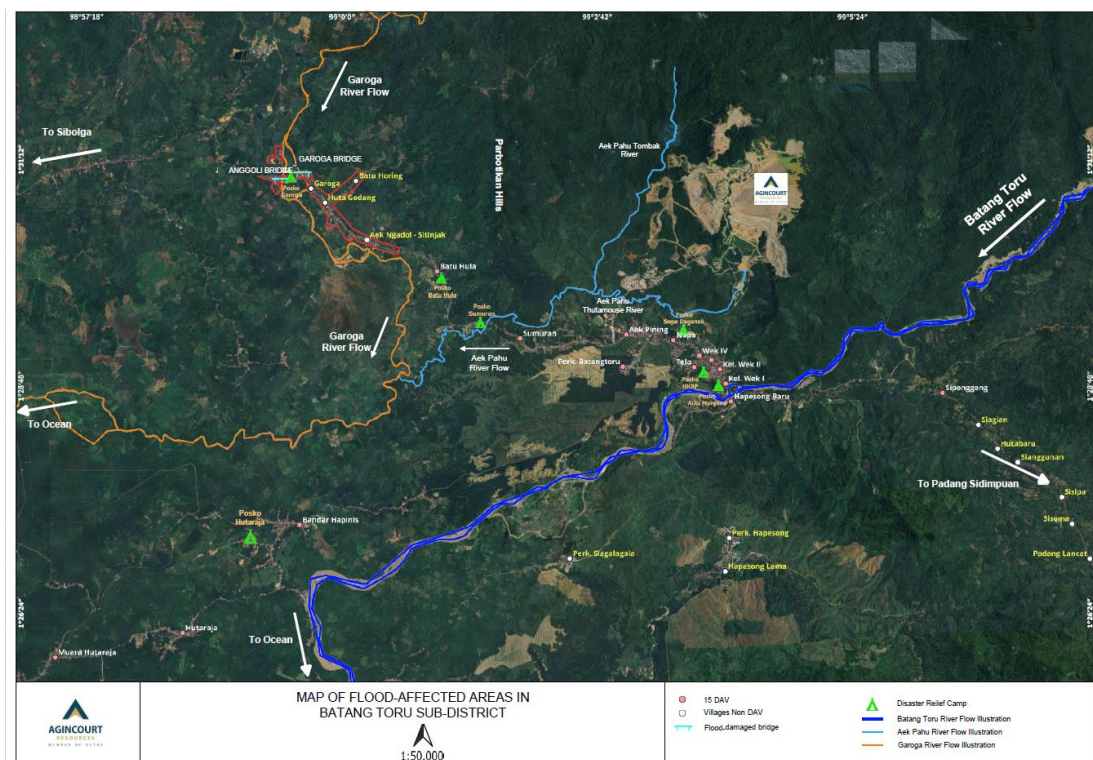
Figure 2. Map of Disaster-Affected Area

- The flood disaster originated primarily in Garoga Village, which lies within the Garoga Sub-Catchment Area (DAS). From this initial location, the disaster spread to several neighboring villages, including Huta Godang, Batu Horing, Sitinjak, and Aek Ngadol (see Figure 2, area inside the red box).

- The flash flood disaster occurred when the Garoga River (colored orange in Figure 2) channel was unable to accommodate the high volume of floodwaters. This condition was triggered by the massive blockage of log materials accumulating at the Garoga I Bridge and the Anggoli Bridge (Garoga II). The blockage reached a critical point on November 25, at approximately 10 a.m., causing a sudden and catastrophic change in the river's path. This change forced two Garoga tributaries to merge into a powerful, single new current that directly struck Garoga Village.

- PTAR operation is located within the Aek Pahu Sub-Catchment Area, which is defined by the Aek Pahu River (Figure 2, light blue). Hydrologically, this area is separate and distinct from the Garoga Sub-Catchment Area upstream of Garoga Village. Although the two rivers eventually meet, their confluence is significantly far downstream of Garoga Village, with the combined flow continuing toward the west coast of Sumatra. Consequently, the mining operation has no effect on the upstream area of the Garoga River.

- Although several landslide events were observed within the Aek Pahu sub-Catchment Area, the Aek Pahu River flow did not experience a flash flood phenomenon. In contrast with the Garoga River, the Aek Pahu river lacked the intensive input of mud and logs that typically causes massive blockages and triggers flash floods. Consequently, the fifteen (15) villages surrounding the mine, which are predominantly situated in the Aek Pahu sub-Catchment Area, experienced no significant impact. These villages are currently functioning as local evacuation centres.
